# Avid Application Note Operation and Maintenance Notes for Avid Extreme Inverter Upgraded Turbines

Document Title:	Operation and Maintenance Notes for Avid Extreme Inverter Upgraded Turbines
Document Number:	AAN-041-REV_00
Author(s):	Gary Pace
Status:	Unrestricted

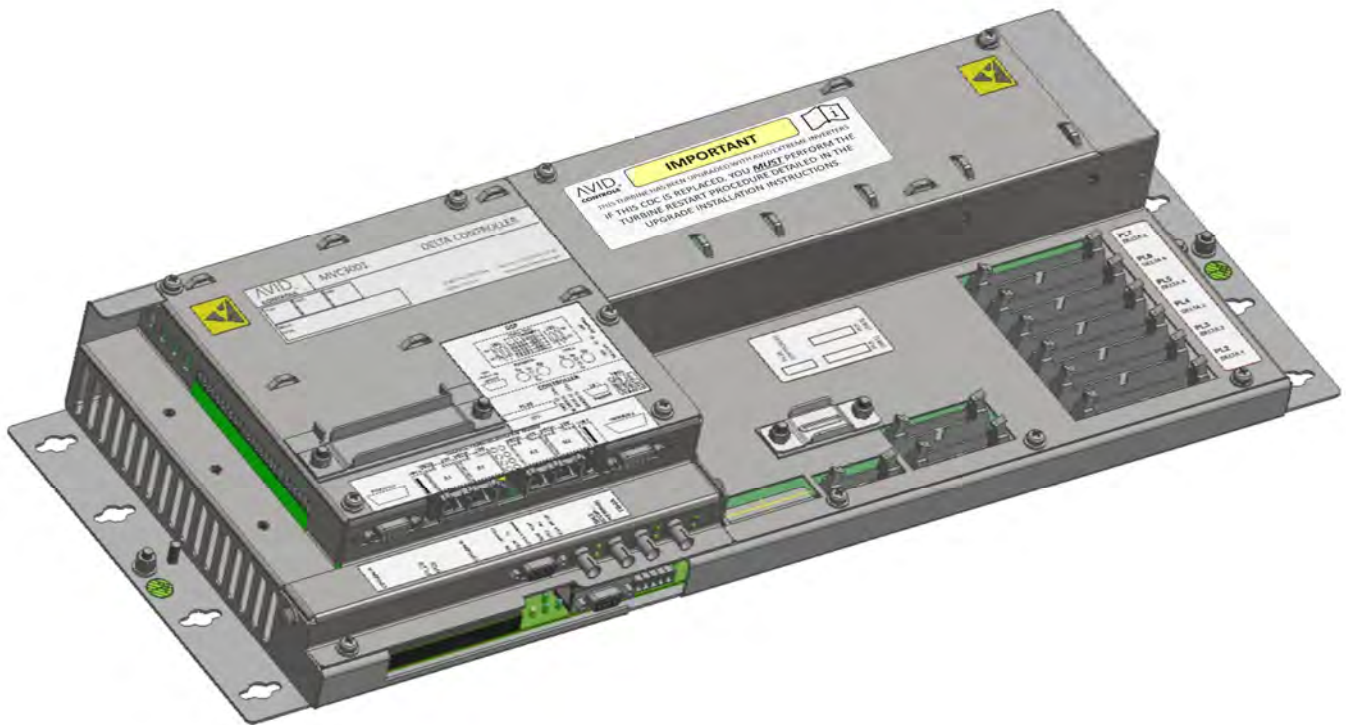
- The upgrade kit provided labels allowing the CDCs to be clearly labelled that this procedure is required:

- If the Upgrade Kit installation instructions were followed, there will be a magnetic envelope on the control cabinet door that contains spare copies of this label.
- Apply one copy to the cabinet back plate underneath the removed CDC, and one copy to the replacement CDC as shown above.
